**REPORT
ON
BARTON MEADOWS
WASTEWATER TREATMENT PLANT**

August 2022

**BY:
ENVIRONMENTAL ENGINEERING &
MANAGEMENT ASSOCIATES, INC.**

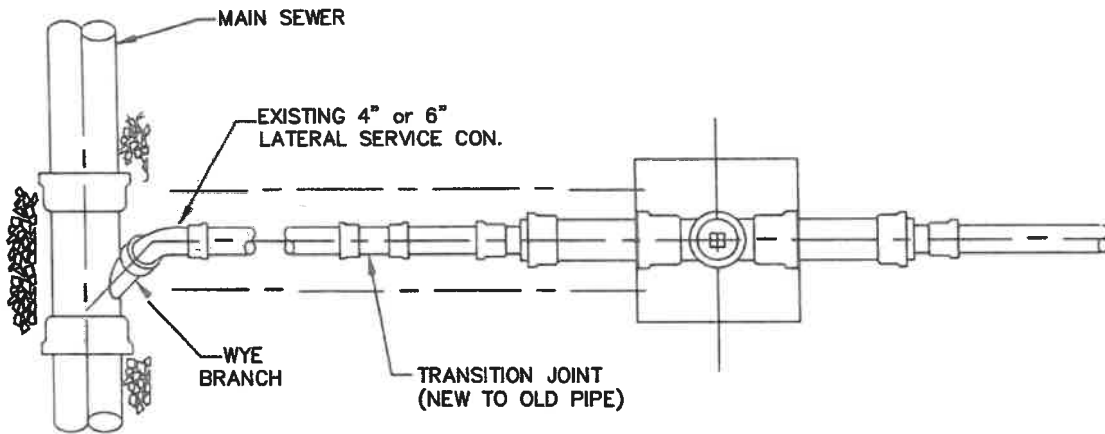
PLAN

1. CLEANOUT IN NON-PAVED AREAS SHALL BE EAST JORDAN #1574, NEENAH FOUNDRY R-1975-A2, OR APPROVED EQUAL. CLEANOUT CAP PROTECTION CASTING SHALL HAVE A MIN. OF 2-INCH OF SEPARATION BETWEEN CLEANOUT THREADED PLUG AND CASTING.

Discussions with your operator, John Scully of Private Utility Enterprises, Inc., confirm this. The main source of inflow appears to be due to broken vents/cleanouts on laterals draining lawns during rain events. These vents were constructed with plastic pipe to within 18 inches of the ground surface, then ductile iron pipe to the surface. The two pieces of pipe were connected by a furnco fitting which is a rubber or elastomer sleeve around the two pipes secured by radiator clamps. These are good

connections until they are flexed, then they can separate. A drive by indicates at least half of the vents have been flexed. All of the vents should be examined.
